***Air Research Technology Inc.***  
Instructions for Continued Airworthiness  
No. ICA17025  
Issue 4, Dec 22, 2012.

Cessna 170, 172 and 175 models modified by installation of *WingExtensions* in accordance with Transport Canada STC Approval Number SA01-35.

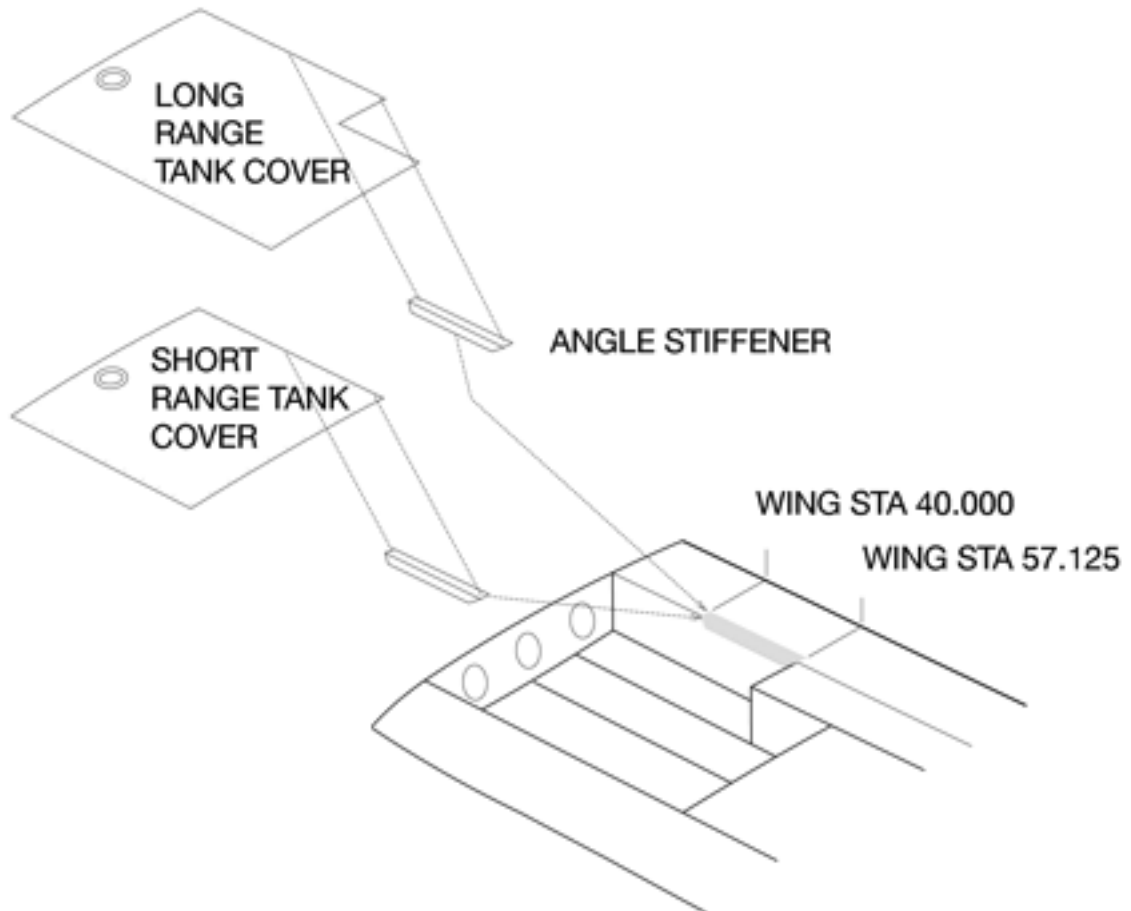
Figure 1: Angle Stiffener, Aft Upper Spar Cap

Item	Area to be Inspected	Inspection Action	Initial
1	Main Spar lower surface reinforcement at Wing Station 100.	Visual inspection for loose or missing fasteners, cracks, and corrosion. Treat any corrosion per AC43.13-1B. Loose rivets must be replaced with CR-3243-6-6 or -7 as applicable.	
2	Main Spar upper surface reinforcement at Wing Station 128 to 160.	Remove inspection panels and visually inspect all structural elements for loose or missing fasteners, cracks, and corrosion. Treat any corrosion per AC43.13-1B. Replace fasteners if required.	
3	Fuel tank well cover inspection on aircraft not equipped with wet wings at aft upper spar cap from wing station 40 to 57.25. (see Figure 1)	Visual inspection to ensure that angle stiffener is present along the aft upper spar cap. Note that screw part number MS27039- 08-08 must be used to secure the angle stiffeners. AN525-10232R8 must be used to secure the WingExtension.
