AIR RESEARCH TECHNOLOGY INC. WINGX STOL

SERVICE BULLETIN

Number SB-1-96 April 11, 1996

Lower Main Spar Cap at Wing Station 100.00

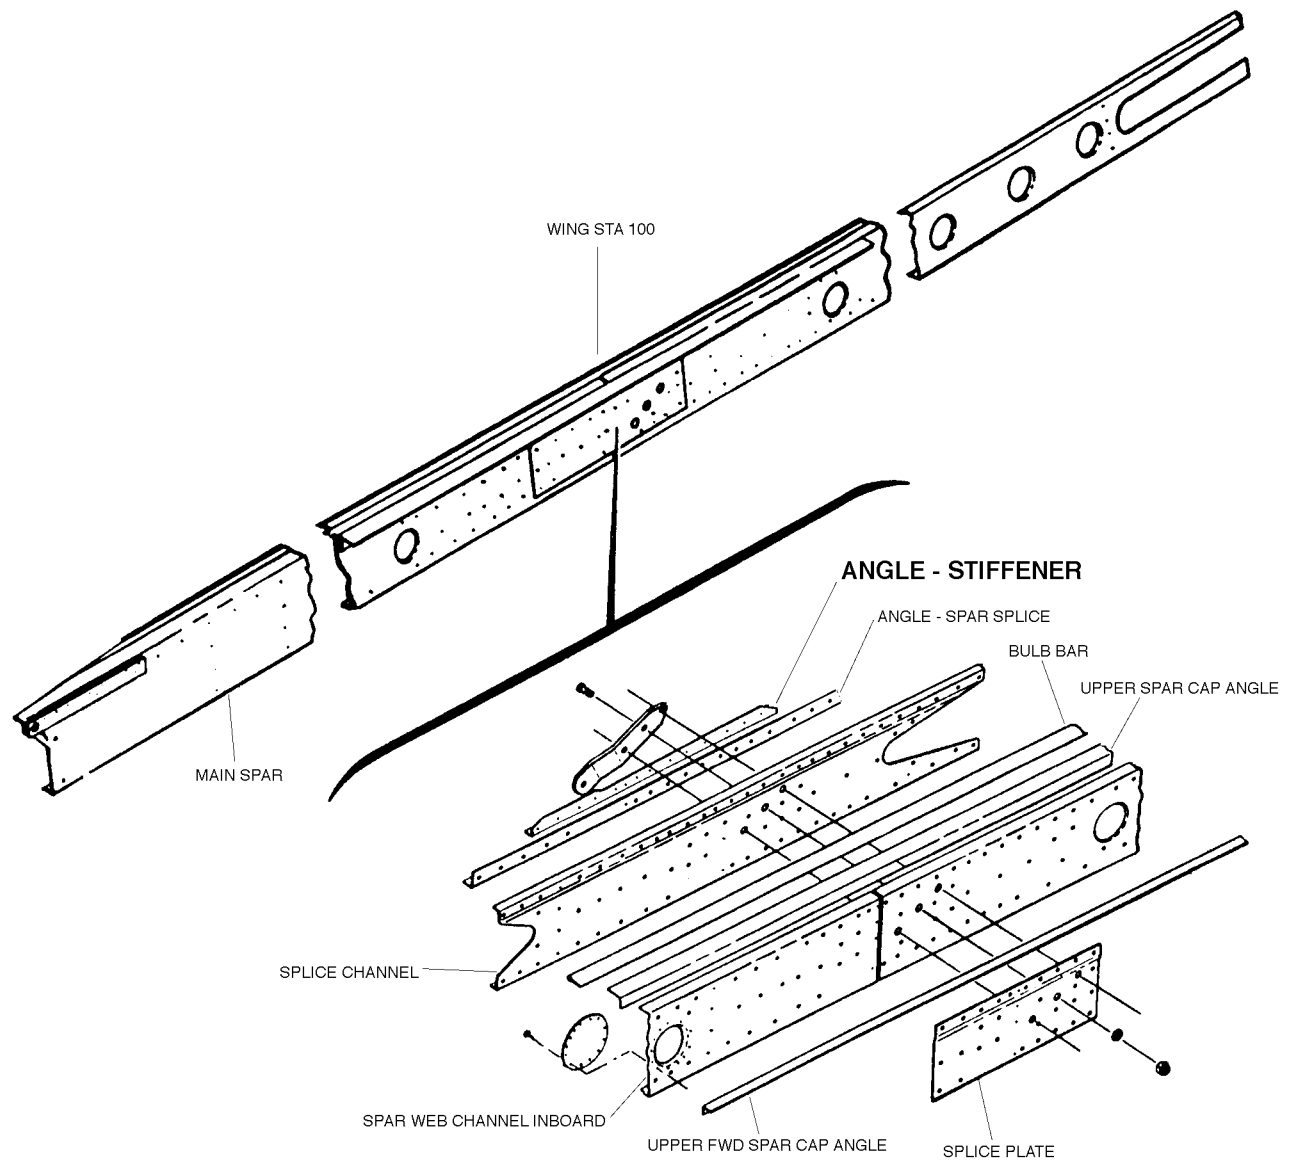
FIGURE 1 - Spar Construction Detail

1) Open the inspection hole situated on the underside of the wing, aft of the spar, closest to where the strut connects to the wing. Using a flashlight and a mirror, by visual inspection, ascertain if the subject wing has the "*angle stiffener*" installed along the lower spar cap between Wing Station 90 and 110 (approximately).

Refer to Figures 1 and 2 to assist identification of the "*angle stiffener*".

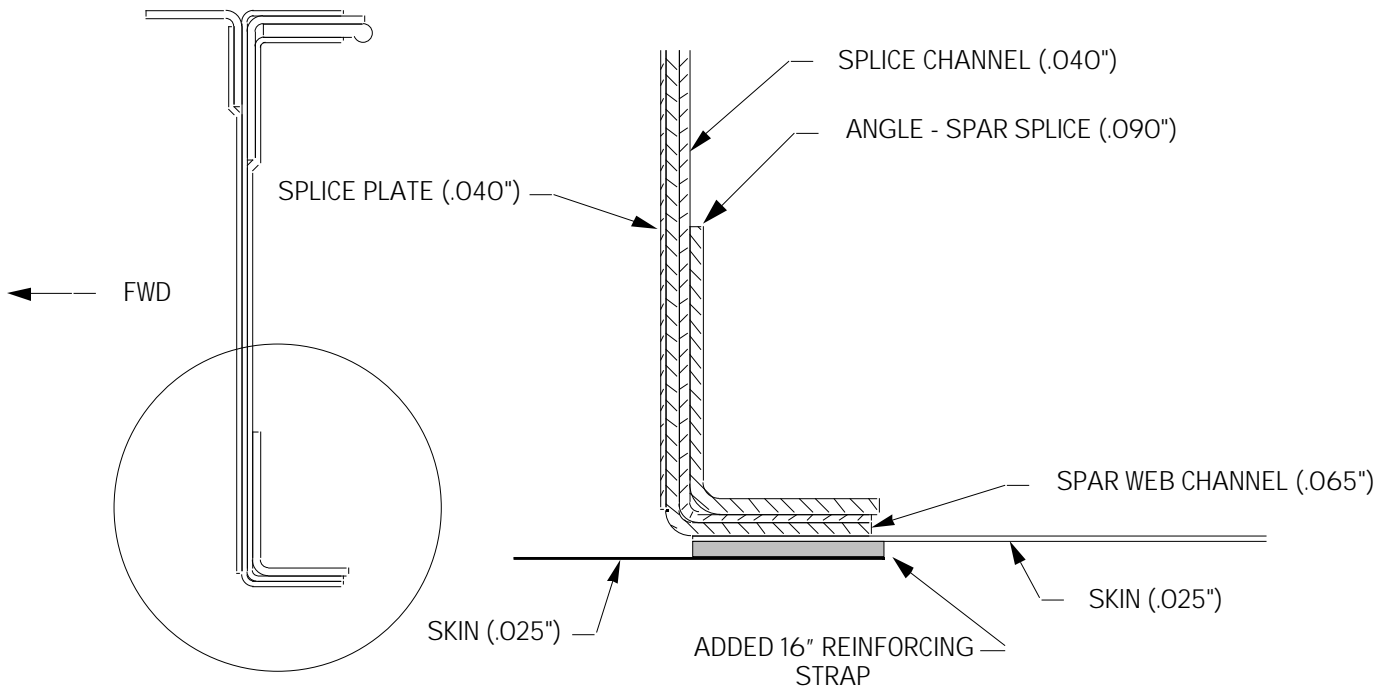
FIGURE 3 - Spar Section Detail
Wing without Angle Stiffener Installed after Part B Modification

Early model wings on the affected aircraft do not incorporate an angle stiffener at the spar splice at wing station 100.00. Static testing performed by A.R.T. has shown that these modified wings do not satisfy the applicable design requirements. The modification introduced by this Bulletin corrects this deficiency.

6) Slide the "s/s strap" under the leading edge wing skins and up against the underwing skin along the spar channel and then center the "s/s strap" at Wing Station 100.50.

7) The "s/s strap", when centered on Wing Station 100.50 at the spar channel splice will be completely hidden, because it is covered by the leading edge wing skins. When the correct position is established, accurately mark the drill hole positions on the "s/s strap", the existing L/E wing skin holes can be used as a guide. Then remove the "s/s strap".

A) The number of holes to be drilled may vary with different aircraft however (7) rivets on each side of the spar splice at Wing Station 100.50 is the minimum required in order to obtain the desired structural strength of the spar splice.

14) Prime the strap with two coats of epoxy primer and allow to dry, then permanently install using CR3213-6-6 universal head CherryMAX rivets. **DO NOT SUBSTITUTE**

A) At Wing Station 100.25 "the leading edge lap joint", install (1) rivet No: CR3213-6-7 universal head CherryMAX rivet " DO NOT SUBSTITUTE ". This longer rivet will allow for the additional thickness at the joint due to leading edge skins overlapping at this point as well as the additional thickness of the center rib at this position.
